METEOROID AND DEBRIS IMPACT FEATURES DOCUMENTED ON THE LONG DURATION EXPOSURE FACILITY

A Preliminary Report

Compiled by Members
of the LDEF Meteoroid
and Debris Special
Investigation Group

August 1990

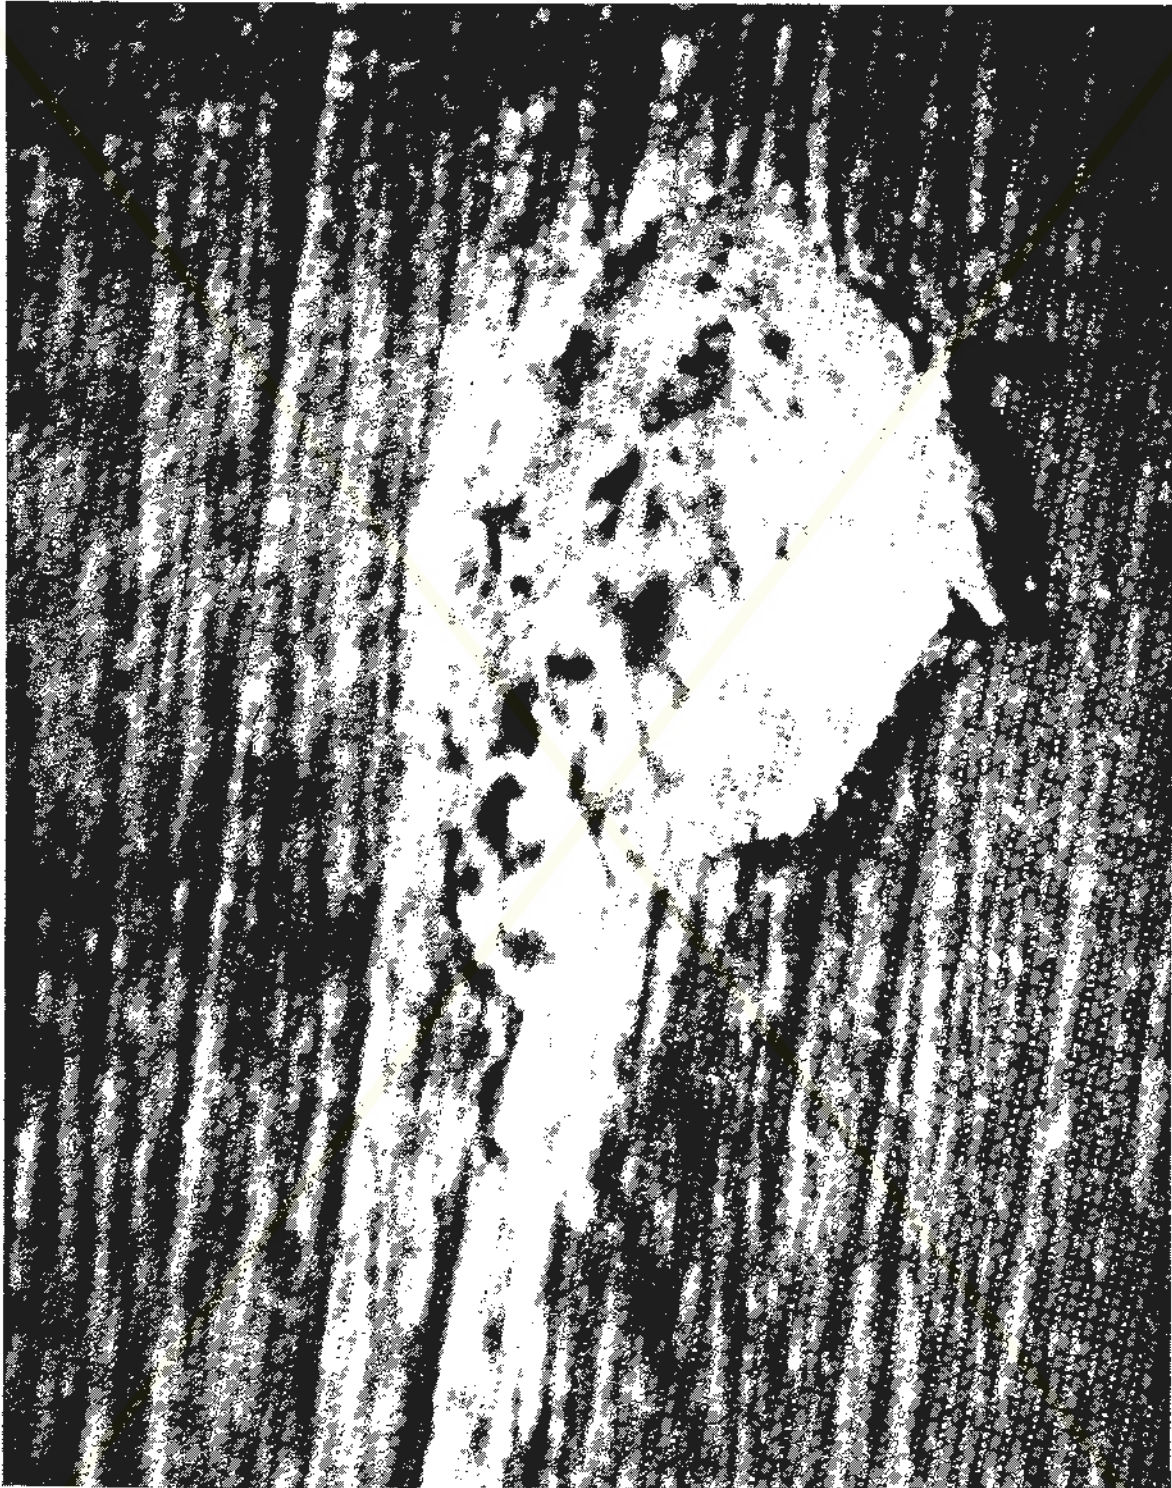
Figure 5. Photograph of an elongate feature in an aluminum surface, probably from an extremely low-angle ($<5^\circ$) or oblique impact. View measures approximately 1.5 cm across.

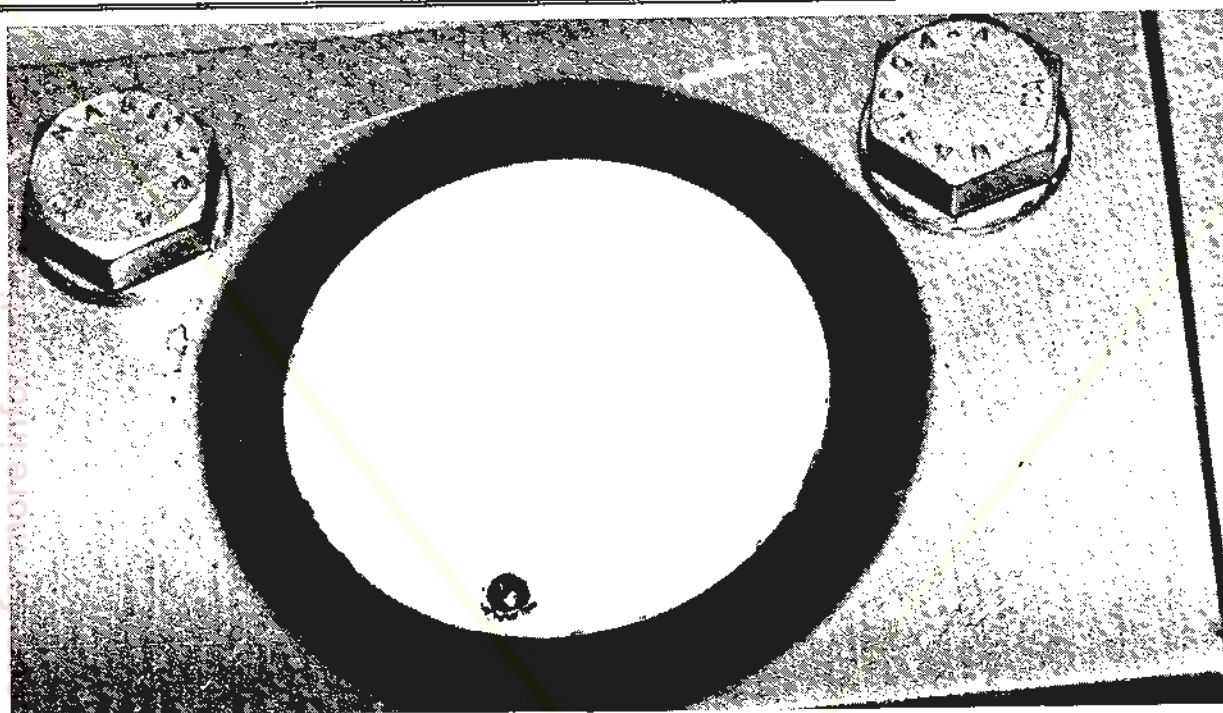
Figure 9. Impact into one of the paint specimens on an experiment-tray clamp. This particular feature was the largest impact feature found on the numerous tray clamps. View measures approximately ~6.5 cm across.
